A Property Inspection Report  
prepared for:

Your Name Here  
Property Address

## Property Inspection Summary

## Property Inspection Report

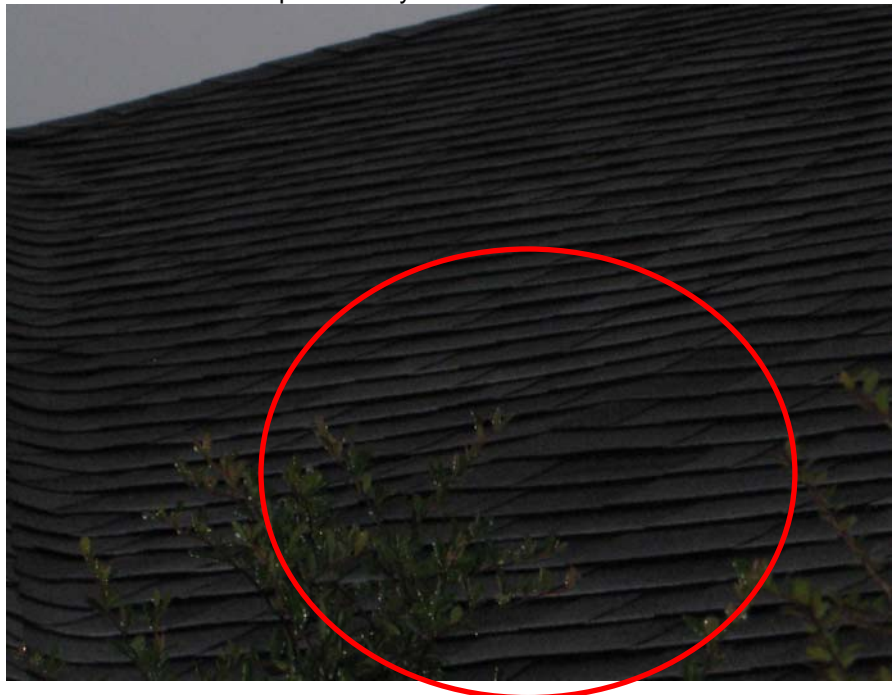
<input type="checkbox"/>	<input type="checkbox"/>	<input type="checkbox"/>	<input checked="" type="checkbox"/>	<p><b>C. Roof Covering</b> (If the roof is inaccessible, report the method used to inspect.)  <i>Comments:</i> Roof was accessed by ladder and observed by walking on roof. Roof material is Asphalt Shingle. Ridge lines appear to be straight and true. Roof slope is estimated as a 4/12 pitch. Shingles appeared to be in good condition. A few nails were observed on ridge shingles which were exposed with no sealant over them. Sealing of the nails with a silicone sealer is recommended. Drip ledge was present and overhung an aluminum gutter on all sides of roof. A cricket was present on uphill side of chimney. All flashing appeared to be in good condition. A slight bulge in the surface of the roof was observed on the west side as shown below. Upon walking on roof the bulge was solid and did not deflect. It is recommended that the homeowner watch this periodically to check for further movement.</p>

**D. Roof Structure and Attic** (If the attic is inaccessible, report the method used to inspect.)  
*Comments:* Attic accessed through attic later in central hallway. Structure appeared to be in good condition with no visible evidence of water intrusion. The area of the roof that appeared to be bulged appears to be the result of a warped rafter. Roof ventilation through a continuous ridge vent and soffit vents. Insulation was approximately 14" thick and was composed of a combination of fiberglass batts and loose fiberglass fill.

15. A bulge in the surface of the roof was observed but does not seem to be soft or moving.
16. Tub in central hallway guest bath observed draining slowly.

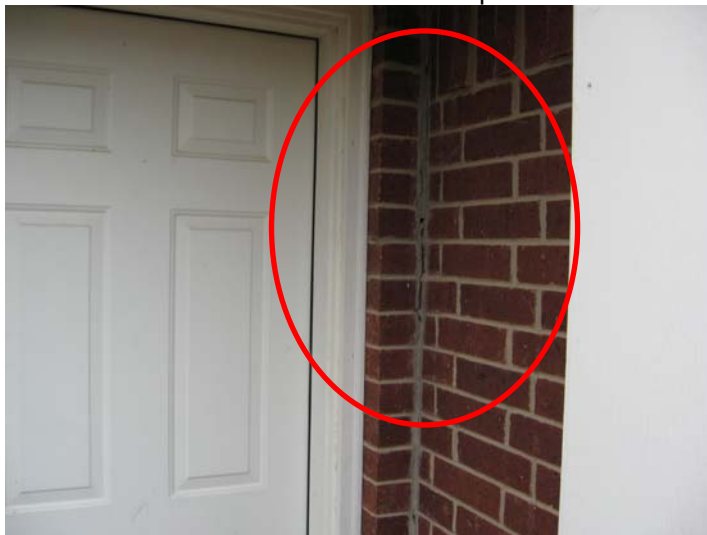
**E. Walls (Interior and Exterior)**  
*Comments:* Interior walls appeared to be in good condition. Brick Veneer at corner by rear garage door had significant deterioration of mortar joint as shown below. Loose mortar should be removed and replace with solid mortar.

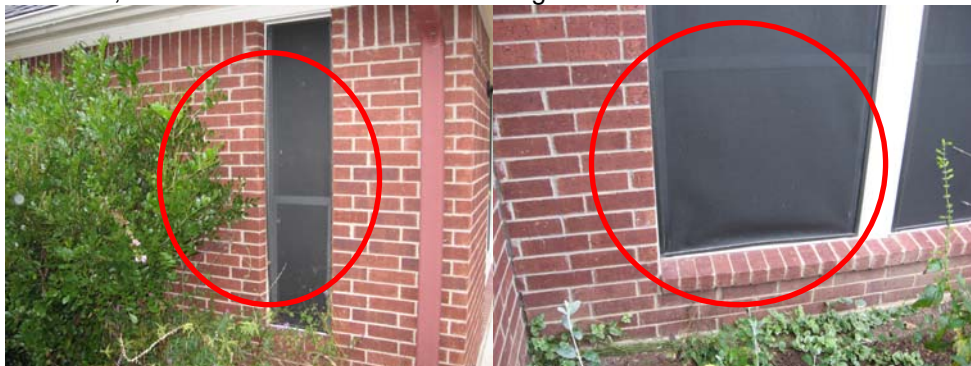
**H. Windows**  
*Comments:* Several window screens were noted as being damaged or not fitting tightly to window frame. Locations were on the North and South side of Master Bedroom, and Southern most window in living room.

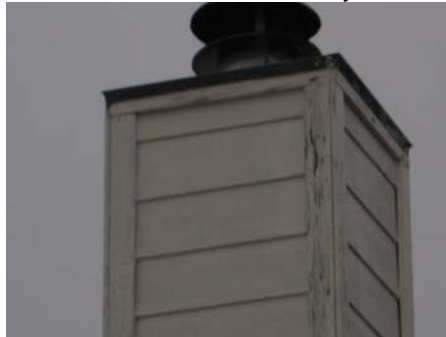
*Comments:* Fireplace, flue, damper and chimney had no visible issues. Recommend painting and caulking the exterior of chimney above roof as the paint has deteriorated considerably.

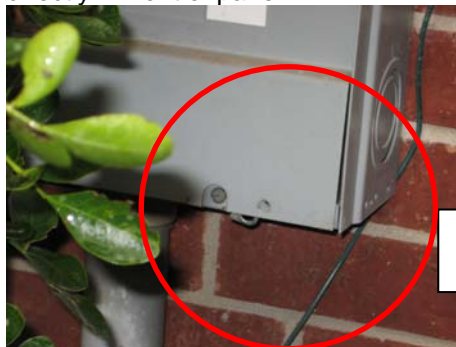
*Comments:* Service enters home through underground entry. Grounding rod not visible although estimated 8 AWG wire was running from grounding bus to below grade presumably to a buried grounding rod. A grounding connection to copper water piping was also observed. Door on main breaker panel would not close and stay latched due to the panel dead front missing a screw on the bottom right corner. This should be corrected immediately as it presents a hazard due to rain and weather intrusion into panel. The result of weather has almost completely erased the breaker labels which need to be re-tagged. Wiring in panel appears to be properly sized and connected. It is always a good idea to have a qualified electrician inspect and tighten electrical connections every couple of years. No Aluminum wiring was observed. Panel location access was hampered by shrubbery. Per code the panel should have a 30" wide by 36" deep access area directly in front of panel.

Missing screw and latch that would not hold panel door shut.

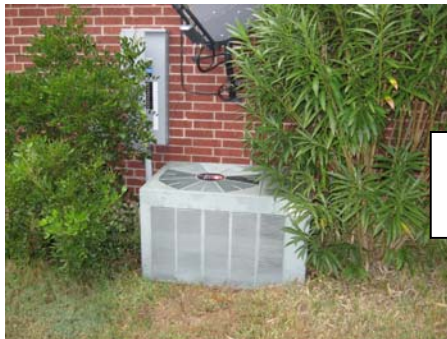
<input type="checkbox"/>	<input type="checkbox"/>	<input type="checkbox"/>	<input checked="" type="checkbox"/>	<b>B. Cooling Equipment</b> <i>Type and Energy Source:</i> Electrical <i>Comments:</i> Unit could not be tested due to temperature being less than 60° F. Unit was checked for leaks with refrigerant tester. Tester picked up some refrigerant leaking at condenser (outside unit). This should be investigated by a qualified air conditioning contractor when the temperatures are warmer. No evidence of refrigerant on evaporator (inside unit). Vegetation around condenser needs to be trimmed back so that 2 to 3 feet of clear space exists around unit.
--------------------------	--------------------------	--------------------------	-------------------------------------	---

Vegetation needs to be trimmed back around both electrical panel and condenser.

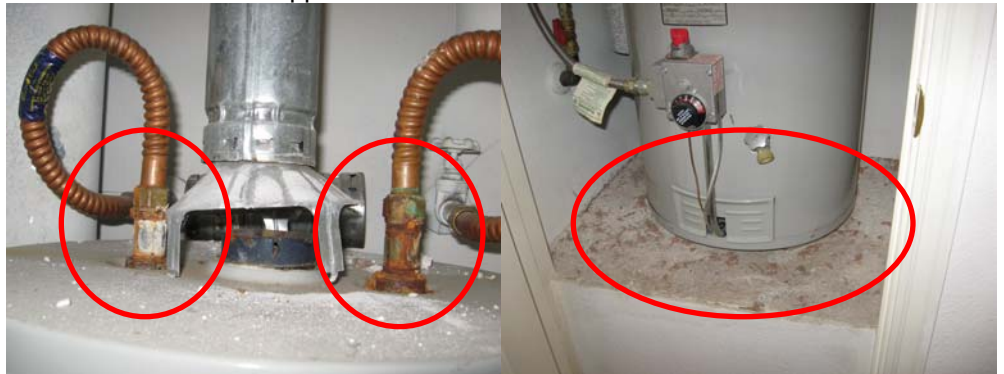
*Comments:* Corrosion of pipe fittings was observed at both the inlet and outlet fittings on the top of the water heater. The leaking pipes appear to have sealed themselves, however should be repaired properly by a qualified plumber. The draft hood also appears to be bent and loose and needs to be repaired by a qualified technician. Temperature and Pressure Relief valve was tested and performed satisfactorily. Unit was observed heating water and a popping sound was noted which typically means there is sediment build up in the bottom of the tank. The water heater needs to be drained and flushed to remove sediment. Burner was observed to have a slightly yellow flame as opposed to blue. Debris and rust particles was observed on the top of the burner. Burner needs to be serviced by a qualified technician. Also noted that the water heater was not sitting in an auxiliary drain pan. It is recommended that a drain pan that is piped to the exterior of the building be installed. Water heater gas piping was tested with gas leak detector and did not find any evidence of leaks. Flue gas and draft hood were tested for combustion gas leaks and did not find any evidence of leaking. Flue vent was Type B vent and installation appeared correct.
