A Property Inspection Report  
prepared for:

# PROPERTY INSPECTION SUMMARY

**By:** Sidney L. Maxwell II, P.E. TREC Lic. No.: 9915 TBD  
(Name and License of Inspector) (PE Lic # 80644) (Date)

# PROPERTY INSPECTION REPORT

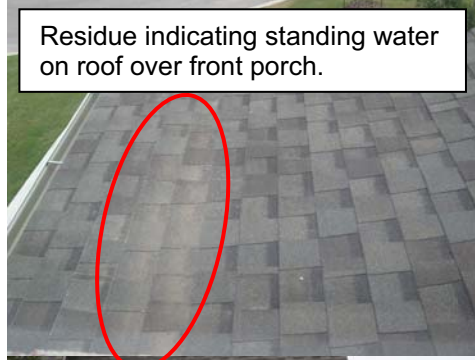
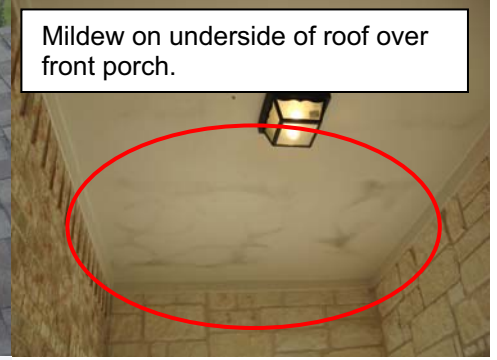
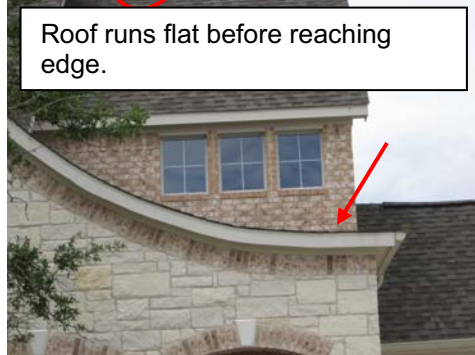
**C. Roof Covering** (If the roof is inaccessible, report the method used to inspect.)  
*Comments:* Roof was not walked on due to extreme pitch (10/12 to 12/12). Roof was inspected by observation from upstairs windows and from the ground with binoculars. Roof appears to be in very good condition with the exception of the area over the front porch which flattens to a zero pitch near the edge of the roof. There is evidence of standing water on the roof and light mildew on porch ceiling below this area shows evidence of water intrusion from the standing water. This needs to be corrected to prevent permanent damage.

1. Roof appears to be in very good condition with the exception of the area over the front porch which flattens to a zero pitch near the edge of the roof. There is evidence of standing water on the roof and light mildew on porch ceiling below this area shows evidence of water intrusion from the standing water. This needs to be corrected to prevent permanent damage.
2. Upon inspection it was discovered that the garage door was disconnected from the operator drive chain. After the door was re-engaged to the drive chain it opened fine but upon closing it kept reversing and had to be disconnected from drive chain to close. More than likely closing force needs to be adjusted.

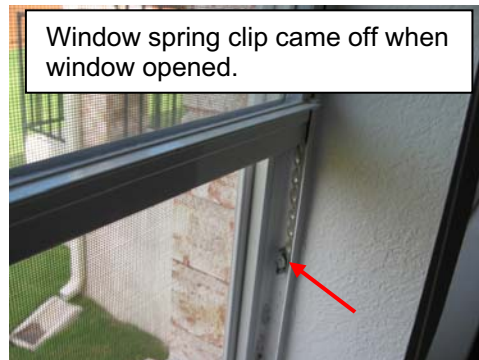
*Comments:* All windows operated with no issues. I did have the spring clip come off the bottom edge of the middle window in the living room and the right master bedroom closet window when opened. I reattached, however this should be monitored..

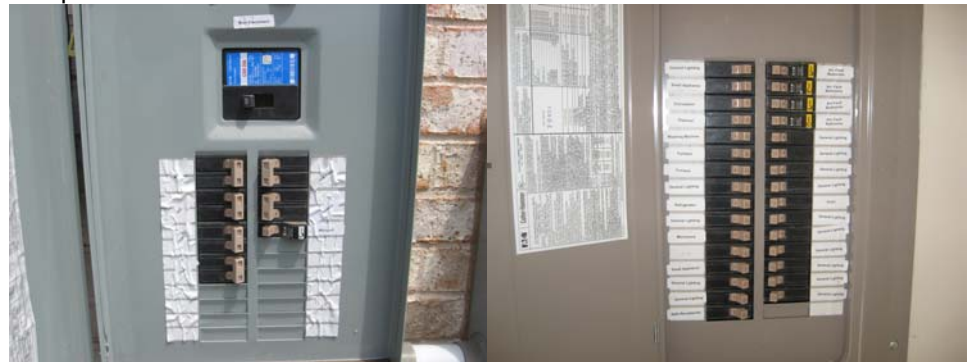
<input checked="" type="checkbox"/>	<input type="checkbox"/>	<input type="checkbox"/>	<input type="checkbox"/>	<b>A. Service Entrance and Panels</b> <i>Comments:</i> 120/240 volt, 200 Amp service fed through underground lateral. Main disconnected located outside by meter with large appliance breakers and breaker for sub panel. Sub panel located in garage with all lighting and receptacle breakers. No issues noted.
-------------------------------------	--------------------------	--------------------------	--------------------------	--

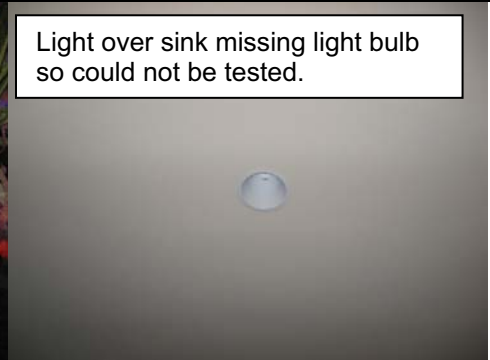
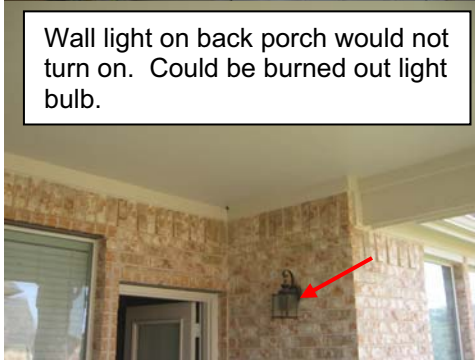
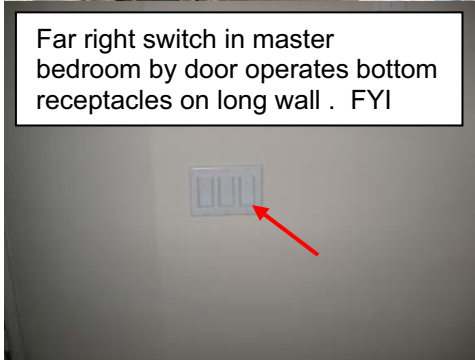
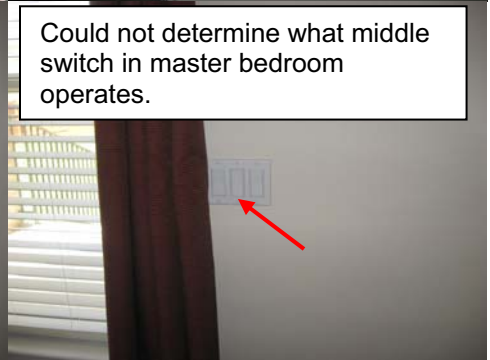
<input checked="" type="checkbox"/>	<input type="checkbox"/>	<input type="checkbox"/>	<input checked="" type="checkbox"/>	<b>B. Branch Circuits – Connected Devices and Fixtures</b> (Report as in need of repair the lack of ground fault circuit protection where required.) <i>Comments:</i> <ol style="list-style-type: none"> <li>Switch to left of kitchen sink by garbage disposal switch does not appear to operate anything. Owner said it does not operate the light directly over sink which is missing bulb.</li> <li>Light over sink is missing bulb and could not be tested.</li> <li>Switch to left of garage side back porch door does not appear to operate anything.</li> <li>Could not find a switch to turn on wall light on back porch so bulb could be burned out which could be the reason for the item above (3).</li> <li>2 of the 3 switches on wall by door in breakfast area do not appear to operate anything. One switch may operate wall light on back porch.</li> <li>Right most switch of 3 on wall in living area operates bottom receptacle on receptacles located on long wall of living area. This comment is just for reference.</li> <li>Middle switch of 3 switches in master bedroom by window does not appear to operate anything.</li> <li>Right most switch of 3 on wall by master bedroom door operates bottom receptacle to the left on the long wall in master bedroom. This comment is just for reference.</li> <li>Middle switch of 3 in dining room by front door does not appear to operate anything.</li> <li>Right most switch of 3 in upstairs bonus room operates bottom receptacle on left side of long wall.</li> </ol>

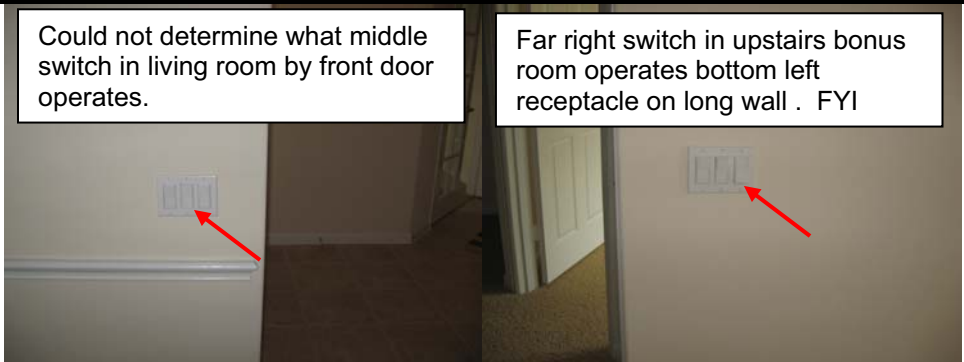
Could not determine what middle switch in living room by front door operates.

Far right switch in upstairs bonus room operates bottom left receptacle on long wall . FYI

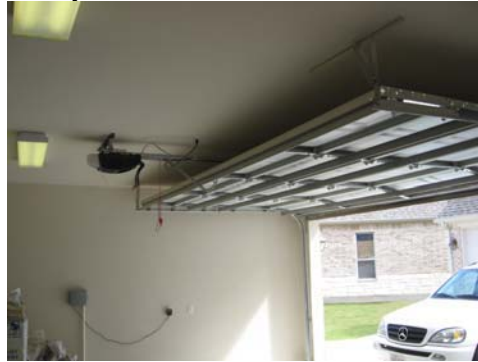
*Comments:* Upon inspection it was discovered that the garage door was disconnected from the operator drive chain. After the door was re-engaged to the drive chain it opened fine but upon closing it kept reversing and had to be disconnected from drive chain to close. More than likely closing force needs to be adjusted.
